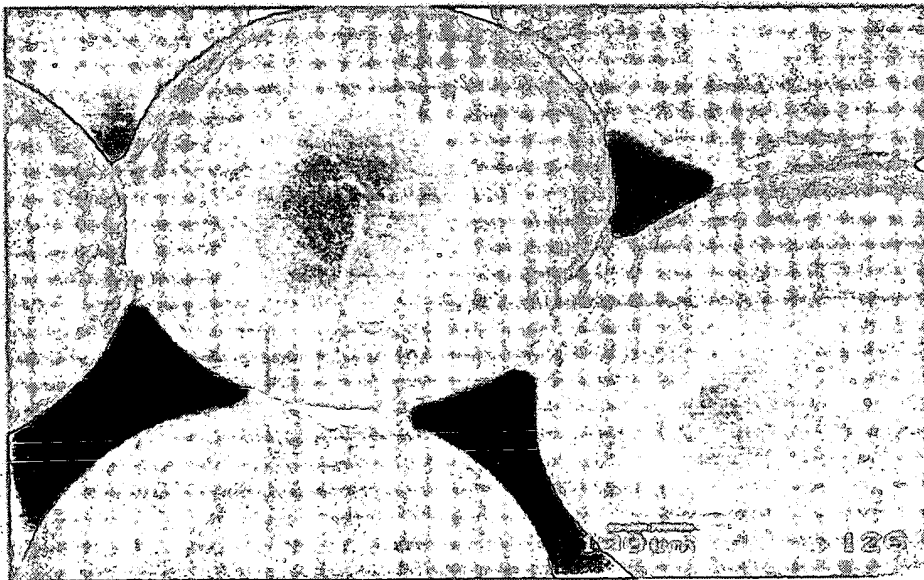
Fig. 7A

SEM micrographs of the Hayes CrCoMo sample after ASTM F746 corrosion test indicates intergranular corrosion attacks.

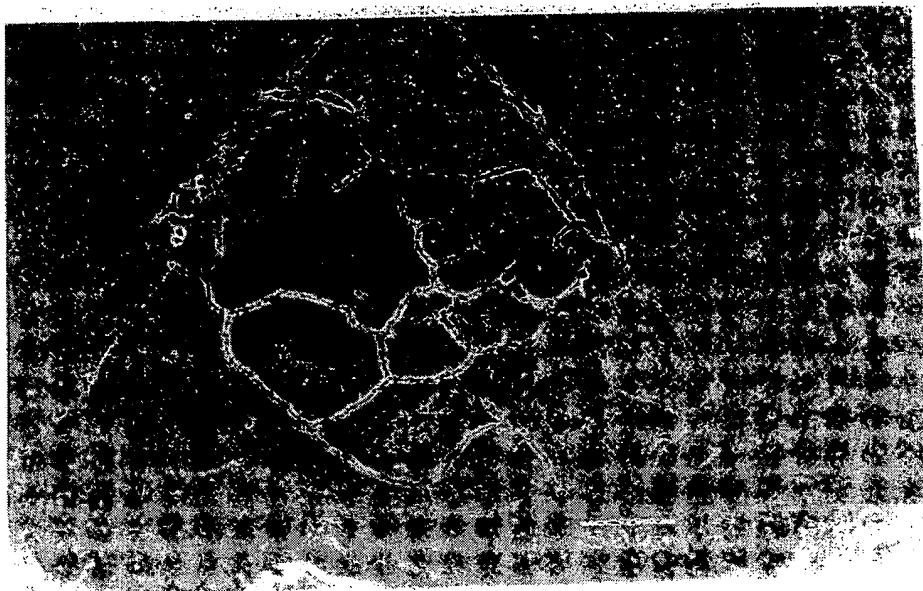
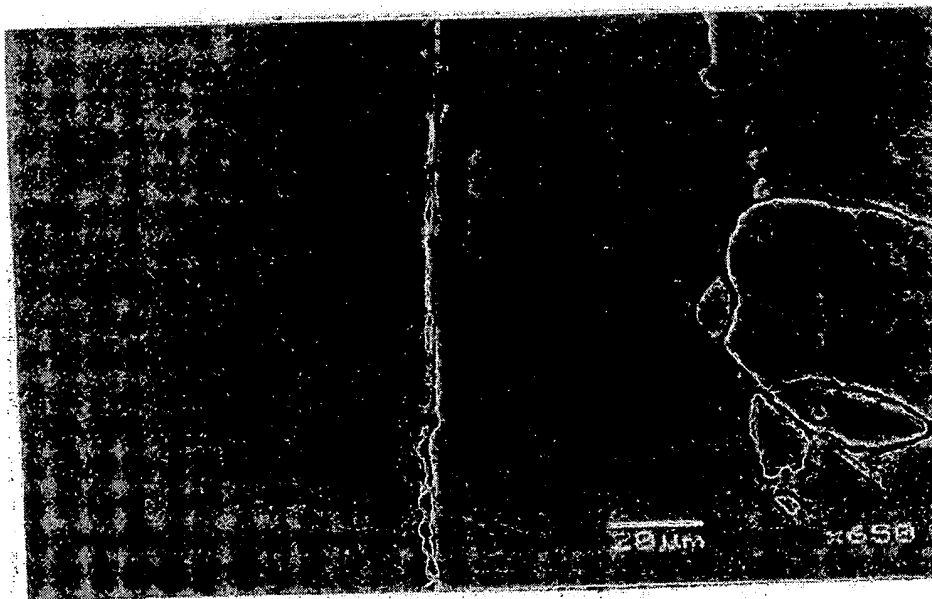
Fig. 7C

SEM micrographs of the Hayes CrCoMo sample after ASTM F746 corrosion test exhibiting corrosion attacks.

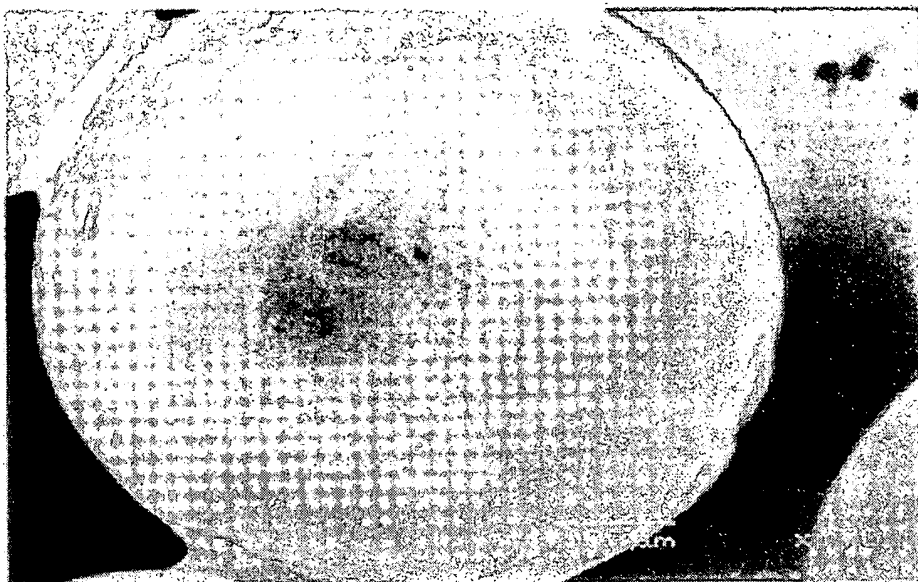
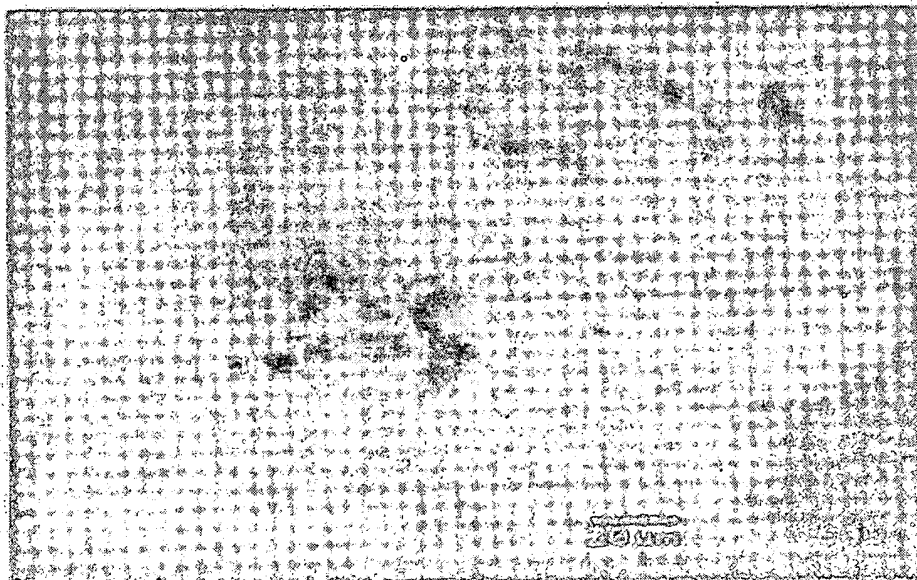
Fig. 8A

SEM micrographs of the Hayes CrCo sample prior to any corrosion test.
